**Flood Control Project Maintenance
Levee Inspections**

Fall 2011 Levee Maintenance Deficiency Summary Report

Reclamation District No. 0307 Lisbon

Levee Inspection Report By Mile - Fall 2011

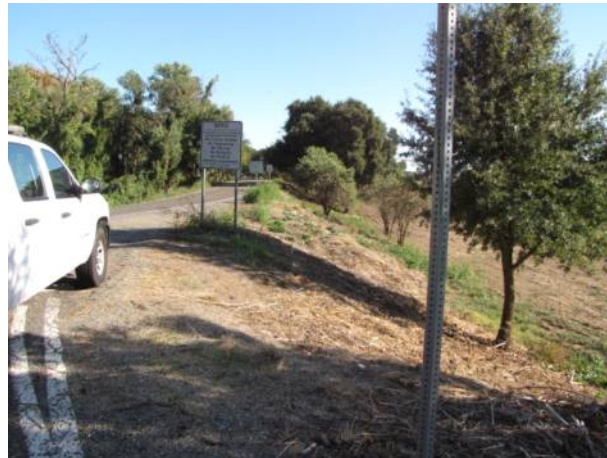
Levee Mile Report Line	1
Start Levee Mile	0.10
End Levee Mile	0.10
Location	Land Side
Category	Earthen Levee
Item	Vegetation

RD 307 landside levee slope looking downstream from levee mile 0.00. Photo taken 10-06-2011.

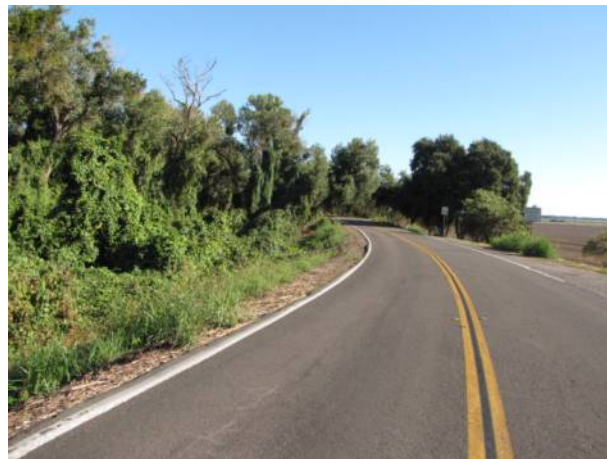
Levee Mile Report Line	2
Start Levee Mile	0.10
End Levee Mile	0.10
Location	Water Side
Category	Earthen Levee
Item	Vegetation

Standing on water side levee mile 0.00 looking downstream of RD 307. Photo taken 10-06-2011.

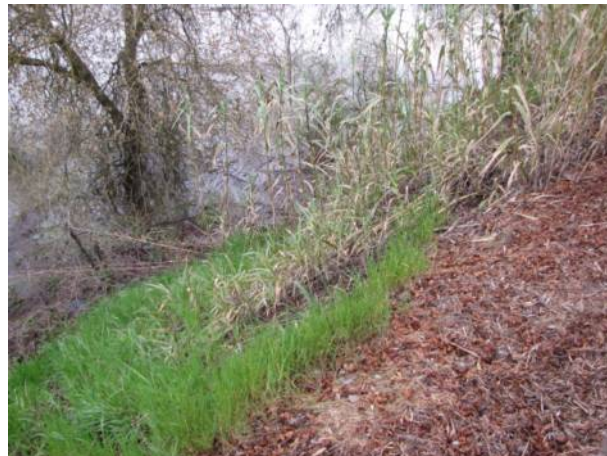
Levee Mile Report Line	8
Start Levee Mile	2.43
End Levee Mile	2.45
Location	Water Side
Category	Earthen Levee
Item	Erosion / Bank Caving

Looking downstream from waterside levee mile 2.43 at erosion on bank, you can't see the erosion very good because of the overgrowth of bamboo. Photo taken 3-18-2011. This site was discovered by the land owner Mr. Borges.

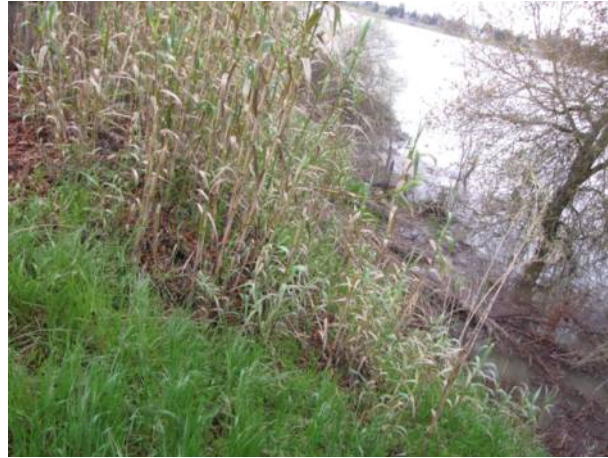
Levee Mile Report Line	8
Start Levee Mile	2.43
End Levee Mile	2.45
Location	Water Side
Category	Earthen Levee
Item	Erosion / Bank Caving

Looking back upstream from levee mile 2.45 end of the erosion, the bamboo has blocked the actual viewing of the eroded site. Photo taken 3-18-2011.

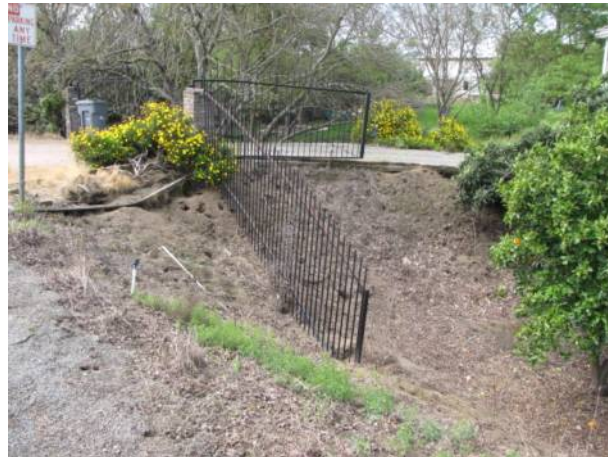
Levee Mile Report Line	13
Start Levee Mile	3.54
End Levee Mile	3.56
Location	Land Side
Category	Earthen Levee
Item	Animal Control

12	3.03	3.03	Earthen Levee	Vegetation	LS	C	Remove the wild growth other than native grasses from the levee slopes.	38.463595 ° -121.505222 °	38.463593 ° -121.505220 °	17
13	3.54	3.56	Earthen Levee	Animal Control	LS	M	Exterminate rodents and backfill and compact or grout burrows. Inspector Comments: There are 40-50 holes within a 37-foot section of levee. Some bait needs to be placed here to eradicate the rodents.	38.560402 ° -121.522426 °	38.538456 ° -121.517120 °	1 Y
14	3.54	3.56	Earthen Levee	Encroachments	LS	C	Pipe Inspector Comments: Landowner has started placing PVC pipe in the slope for a sprinkler system. There is no permit for the installation.	38.560402 ° -121.522426 °	38.538456 ° -121.517120 °	24
15	3.67	3.70	Earthen Levee	Trim / Thin Trees	LS	M	Trim trees to at least five feet above ground level.	38.454548 ° -121.503153 °	38.454177 ° -121.503032 °	29

This photo shows rodent holes in slope and within ramp. There actually is a rodent in view by the iron fence just about 3-foot from the bottom of the fence line.

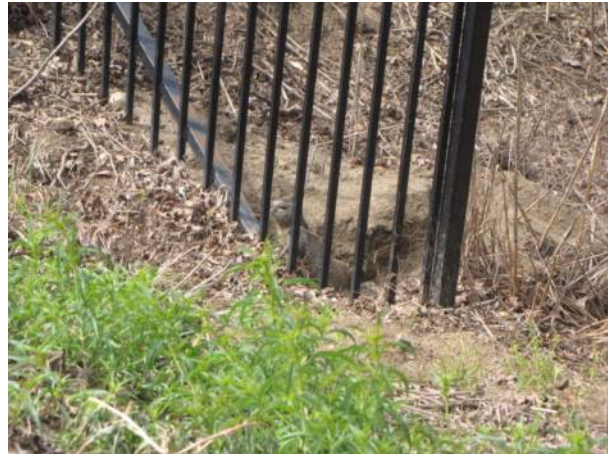
Levee Mile Report Line	13
Start Levee Mile	3.54
End Levee Mile	3.56
Location	Land Side
Category	Earthen Levee
Item	Animal Control

Photo shows a live rodent near fence outside of his burrow.

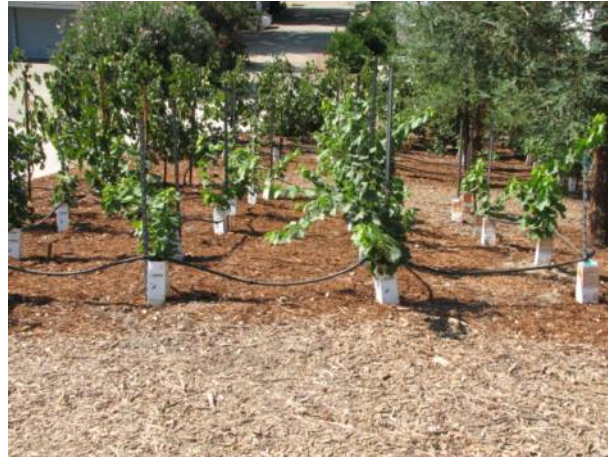
Levee Mile Report Line	25
Start Levee Mile	4.43
End Levee Mile	4.44
Location	Land Side
Category	Earthen Levee
Item	Encroachments

Unauthorized grape vines with driplines placed within levee shoulder and slope, levee miles 4.43 to 4.44 38.443798 121.50332 and 38.44365086 - 121.50322 land side. There is no permit for this encroachment.

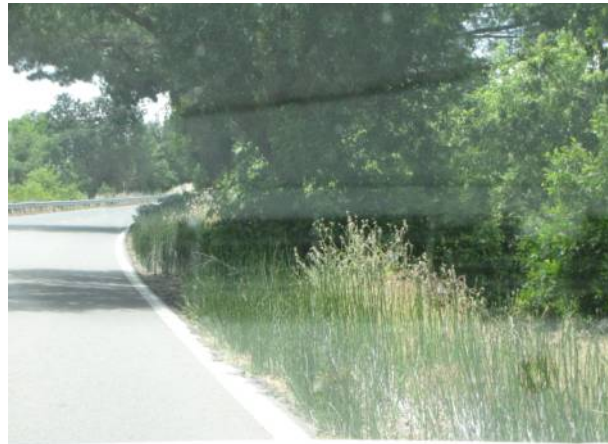
Levee Mile Report Line	38
Start Levee Mile	5.16
End Levee Mile	5.20
Location	Water Side
Category	Earthen Levee
Item	Vegetation

Wild growth on landside at levee mile 5.16 to 5.20 looking down stream.

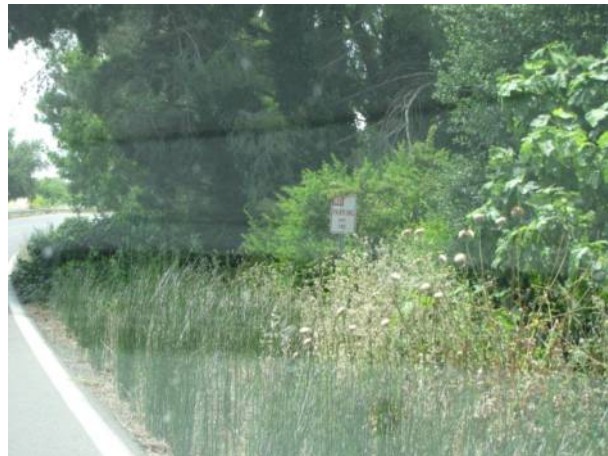
Levee Mile Report Line	38
Start Levee Mile	5.16
End Levee Mile	5.20
Location	Water Side
Category	Earthen Levee
Item	Vegetation

Looking downstream levee mile 5.16-5.20.

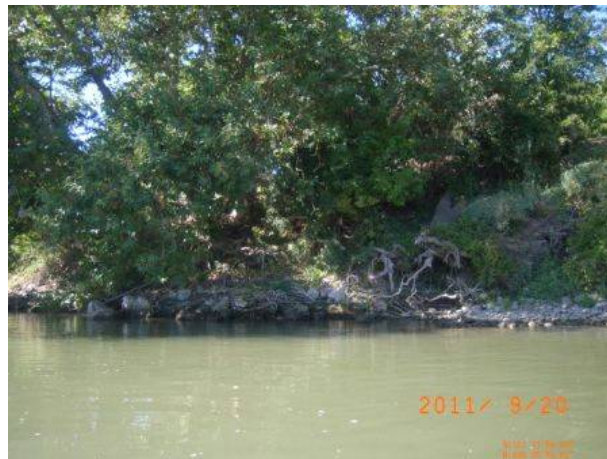
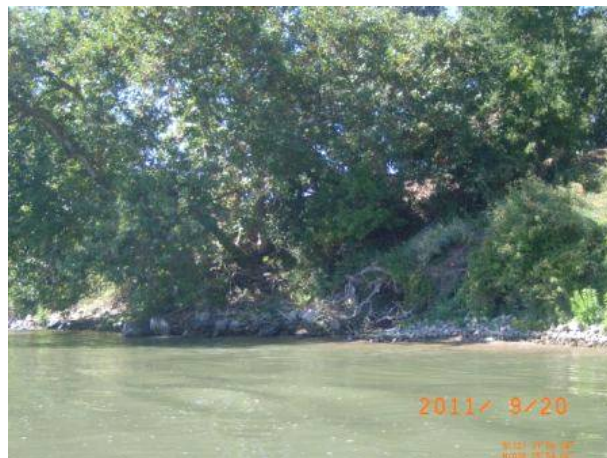
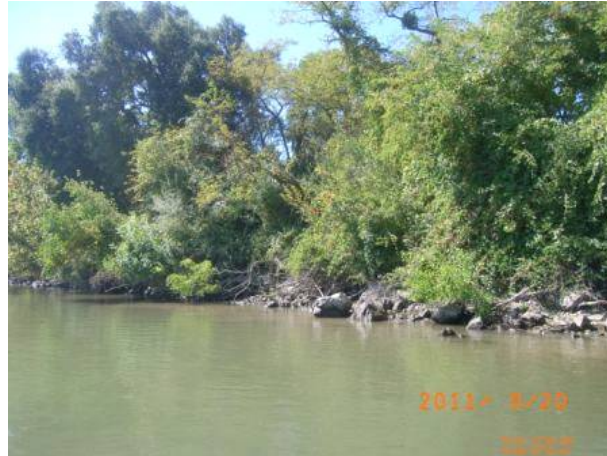
Levee Mile Report Line	46
Start Levee Mile	6.38
End Levee Mile	6.49
Location	Water Side
Category	Supplemental
Item	USACE Erosion Survey

46	6.38	6.49	Supplemental Survey	USACE Erosion Survey	WS	M	Inspector Comments: 2011: Erosion pockets likely from tree popouts. This site has been in the inventory before and been fixed with emergency bank rock but continues to fail. [2011 Site ID: SAC_43-1_R]	38.431726 ° -121.533200 °	38.429957 ° -121.533035 °	7 Y
